Waterfront Housing Burlington, Vermont

Owner: Housing Vermont & Burlington Community Land Trust

Services Provided: Civil, geotechnical and structural engineering, plus construction inspection & testing.

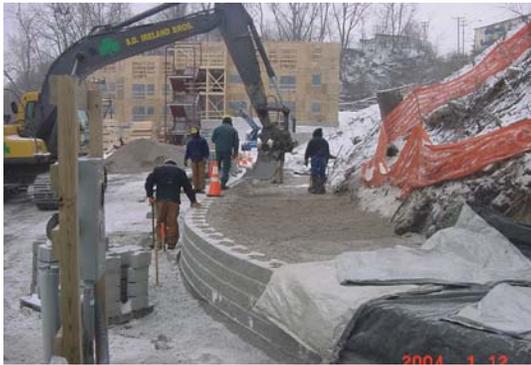
MSE Wall at Parking Lot (Southeast)

Design Approach: The selected design approach, based upon cost and aesthetics, utilized a reinforced slope between the proposed building and Depot Street and a soil-reinforced masonry wall between the parking lot and Depot Street. The minimum design Factors-of-Safety were 1.5 and 1.3, respectively. Along the northerly perimeter (adjacent to Burlington College), the design approach was to preserve most of the old tree growth and situate the building so that no slope failures with Factors-of-Safety less than 1.5 would affect the proposed building. An additional block retaining wall was required to separate the project from existing railroad tracks along the western portion of the site. Loose soil conditions resulted in bearing capacities of only 2000 PSF.

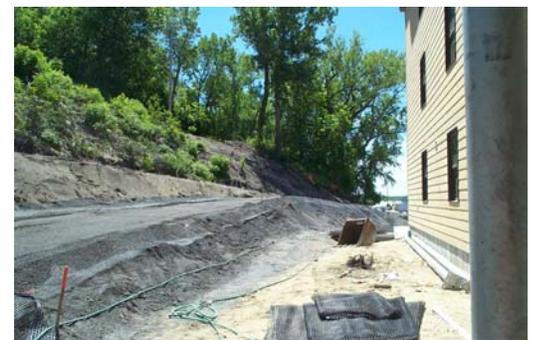
Reinforced Slope (East)
