## Waterfront Housing Burlington, Vermont

**Owner:** Housing Vermont & Burlington Community Land Trust

**Services Provided:** Civil, geotechnical and structural engineering, plus construction inspection & testing.

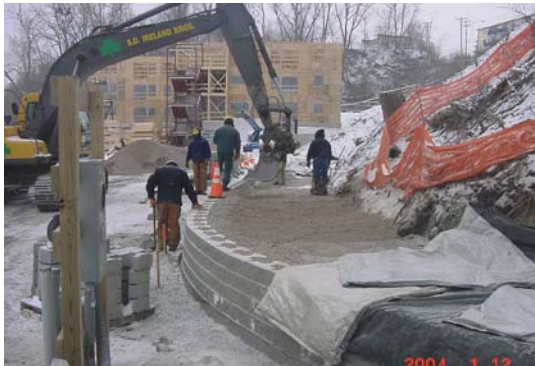
**MSE Wall at Parking Lot (Southeast)**

**Design Approach:** The selected design approach, based upon cost and aesthetics, utilized a reinforced slope between the proposed building and Depot Street and a soil-reinforced masonry wall between the parking lot and Depot Street. The minimum design Factors-of-Safety were 1.5 and 1.3, respectively. Along the northerly perimeter (adjacent to Burlington College), the design approach was to preserve most of the old tree growth and situate the building so that no slope failures with Factors-of-Safety less than 1.5 would affect the proposed building. An additional block retaining wall was required to separate the project from existing railroad tracks along the western portion of the site. Loose soil conditions resulted in bearing capacities of only 2000 PSF.

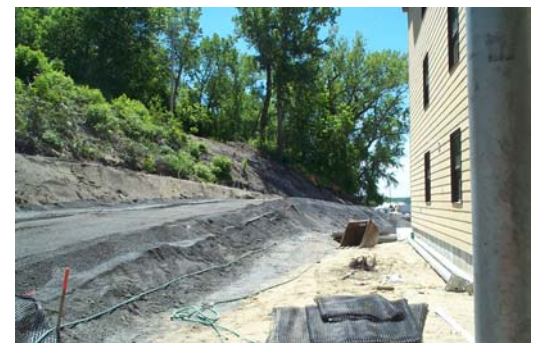
**Reinforced Slope (East)**
