Waterfront Housing Burlington, Vermont

Owner: Housing Vermont & Burlington Community Land Trust

Services Provided: Civil, geotechnical and structural engineering, plus construction inspection & testing.

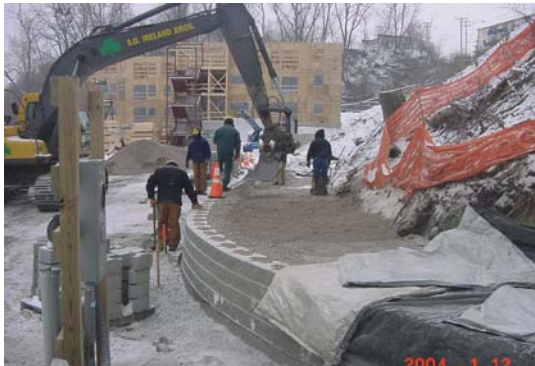
MSE Wall at Parking Lot (Southeast)

Design Approach: In order to improve slope stability and reduce the chance of contact with the soil contaminants, the site was capped with 4 to 10 feet of soil. Reinforced slopes were used east of the proposed building and a soil-reinforced masonry wall was used east of the parking lot. An additional block retaining wall was required to separate the project from existing railroad tracks along the western portion of the site. Site access was provided by a 400-foot long extension of Lake Street. Stormwater treatment was achieved by means of an off-site sand filter connected to the new stormwater outfall for Lake Street Extension. The new sanitary pump station required a radio link to the receiving College Street pump station to prevent operation during any shutdowns of that station.

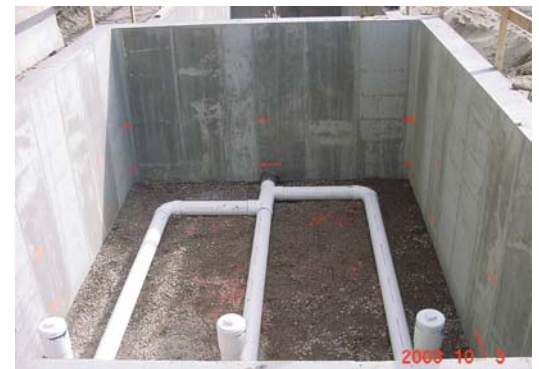
Sand Filter for Stormwater

Concept Design: Site grading concepts had to incorporate slope stability concerns with the findings of the Phase 2 Environmental Assessment Report. Site stormwater treatment needed to result in 80% removal of TSS and 40% removal of phosphorus for LEED certification. The limited shape and size of the lot did not permit the use of aboveground treatment ponds or ditches. It was also found desirable for the LEED certification to leave most of the old foundations intact. Sanitary sewage was to be disposed of by means of a new gravity sewer and pump station.
